Quality Assurance and Source Inspection

Contract #: 04-0120F4Cty: SF/ALA Rte: 80 PM: 13.2/13.9File #: 69.28**WELDING INSPECTION REPORT****Resident Engineer:**Pursell, Gary**Address:** 333 Burma Road**City:** Oakland, CA 94607**Report No:** WIR-013064**Date Inspected:** 15-Apr-2010**Project Name:** SAS Superstructure**OSM Arrival Time:** 700**Prime Contractor:** American Bridge/Fluor Enterprises, a JV**OSM Departure Time:** 1900**Contractor:** Zhenhua Port Machinery Company, Ltd (ZPMC), Changxing Island **Location:** Shanghai, China**CWI Name:** Mr.Tian Lei**CWI Present:** Yes No**Inspected CWI report:** Yes No N/A**Rod Oven in Use:** Yes No N/A**Electrode to specification:** Yes No N/A**Weld Procedures Followed:** Yes No N/A**Qualified Welders:** Yes No N/A**Verified Joint Fit-up:** Yes No N/A**Approved Drawings:** Yes No N/A**Approved WPS:** Yes No N/A**Delayed / Cancelled:** Yes No N/A**Bridge No:** 34-0006**Component:** Orthotropic Box Girder(OBG)/TOWER**Summary of Items Observed:**

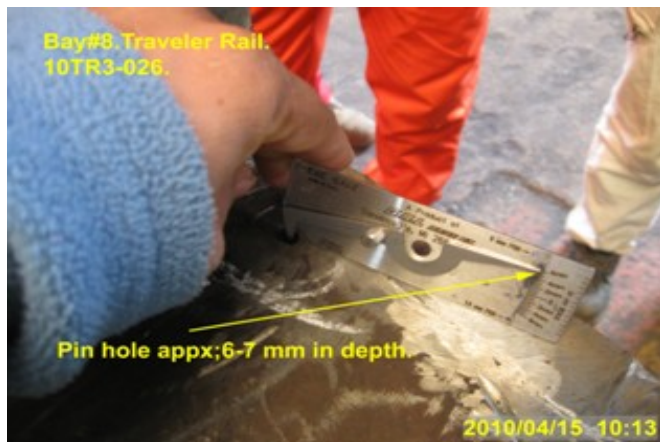
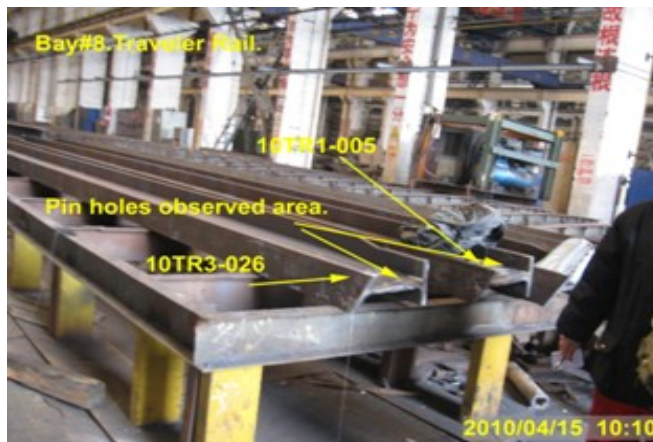
- TR-10TR3-026-One pin hole and 10TR1-005-Three pin holes observed on web Base metal adjacent to the buttering performed area. Approximately 6 to 7 mm in depth.
- The Y Locations are approximately 30 mm from the edge.
- The Base metal thickness to be measured 25 mm.
- The TR designated as Non Seismic Performance Critical Member (Non-SPCM) on the approved drawing.
- ZPMC QC and American Bridge/Fluor (AB/F) will take the approval from the Caltrans Engineer to perform the base metal Repair of these locations by welding.
- The attached photographs provide additional detail.
